Some Chemicals for Control
of
Erosion Caused By Rain

The area selected for the test is on a realignment of Road 05-Mon-101 between San Ardo and San Lucas (Contract No. 05-025214). The average annual rainfall for this area is approximately 10½ inches per year, nearly all of which occurs between October and May.

The test plots are located on a southwest facing cut slope with a 2:1 slope design. These plots are between Station 427+00 and Station 430+75 and are 15 feet wide and 40 feet high. The cut is located in the alluvial deposits adjacent to the west side of the Salinas River. The material is unconsolidated fine-grained sand and silt which is highly erodible as shown in Plates 1, 2, and 3. The uniformity of material throughout the test area was checked both for grain size and mineral content. No appreciable differences were found. A distinct difference in appearance of the soil developed after the slope was prepared for treatment. This was caused by the addition of fine material from surface material at the top of the cut as well as from previously undisturbed material in the cut face itself.

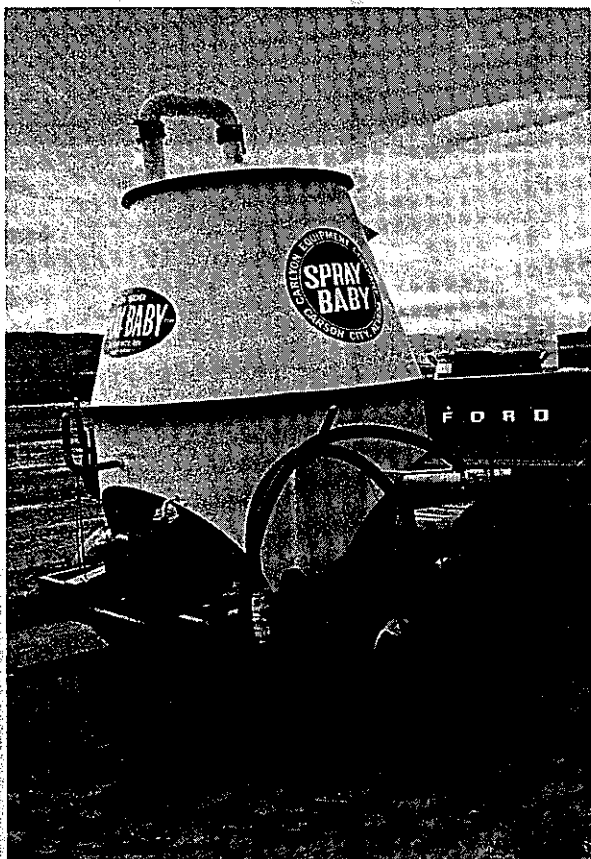
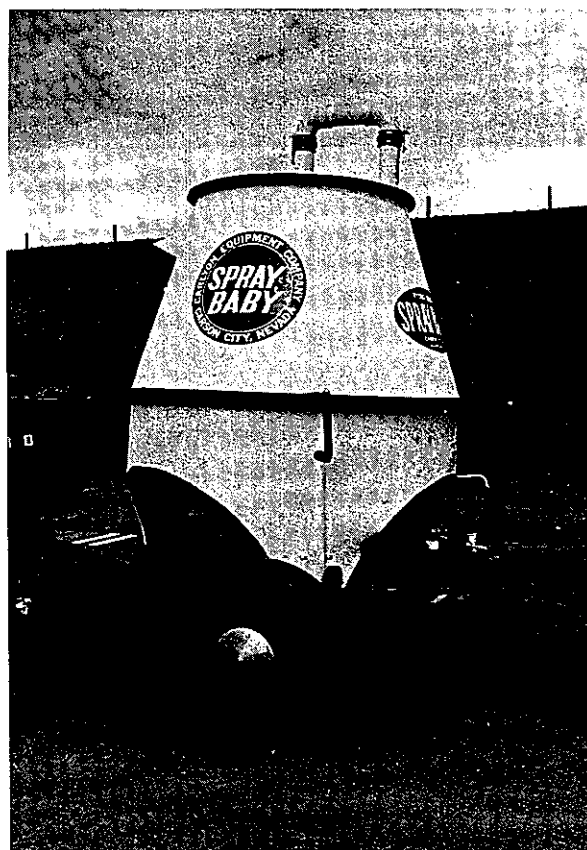
Plate 4

Rental spray rig used
to apply all products
included in this test.

All products were prepared and applied by personnel of the Materials and Research Department. The trailer-mounted sprayer pictured in Plates 4 and 5 was used for every application. The tank had a 150-gallon capacity which was more than adequate for the size of the test plots. The inside of the tank was marked at 5-gallon intervals to facilitate the proportioning operations in the field. A continuous and vigorous agitation system is built into the sprayer to assure delivery of a uniform mixture through the spray nozzle. The pump is driven by a 7½ HP Briggs and Stratton 4-cycle engine.

The proportioning, mixing, and spraying operations all went smoothly and without equipment failure. Two problems were experienced with the sprayer, both of which have subsequently been corrected by the manufacturer. The pump size was too small and did not deliver enough pressure at the nozzle, and for some of the materials, the agitation was too vigorous and resulted in a frothy mixture which would not penetrate the soil well. For this project a smaller diameter nozzle was used to maintain pressure, and a chemical antifoaming agent was added to those products which exhibited the foaming property.

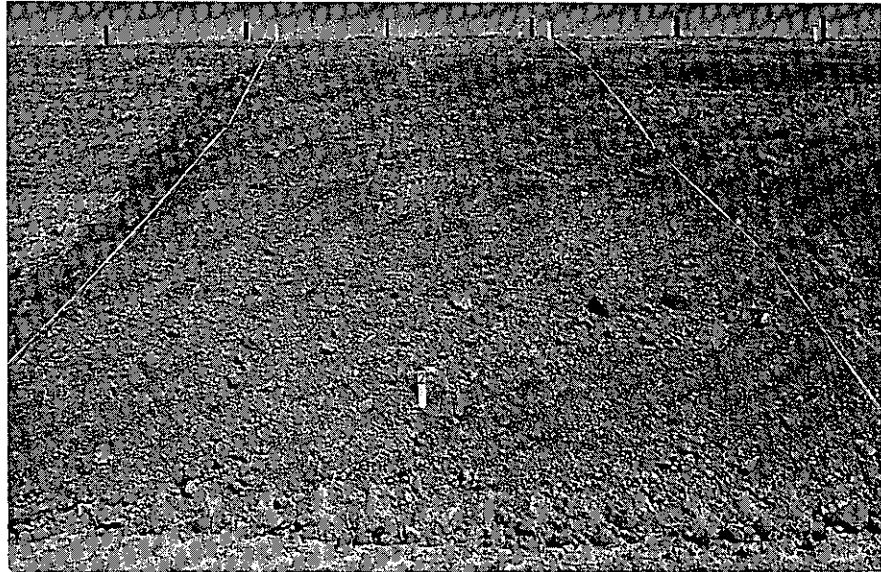
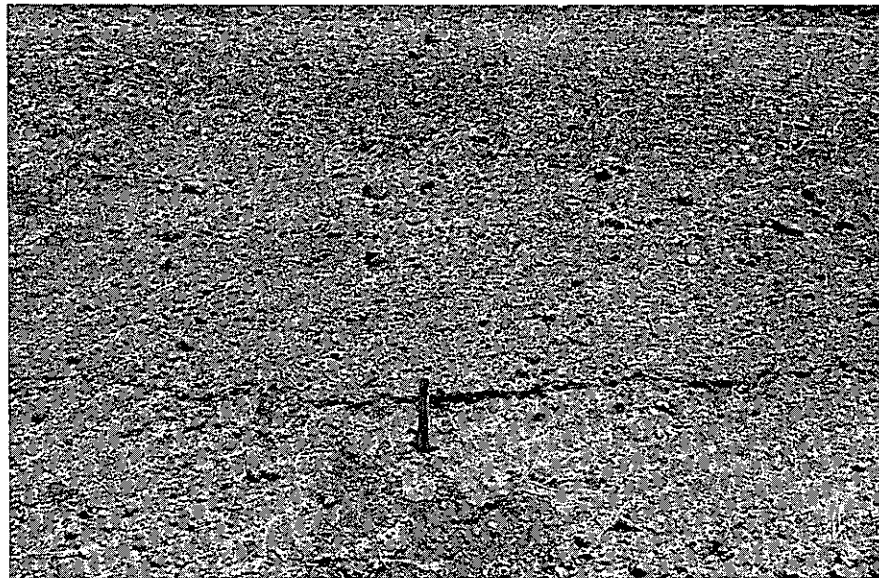
Verdyol Super - Seeded

Plates 9 and 29 show the Verdyol treated test slopes.

Weathering for four months resulted in a weak crust on both test plots, which probably will not aid in controlling erosion. On the unseeded plot some native plants sprouted, primarily on the roller path. On the seeded plot a very few seeds germinated but some of these were rye grass, which was unusual.

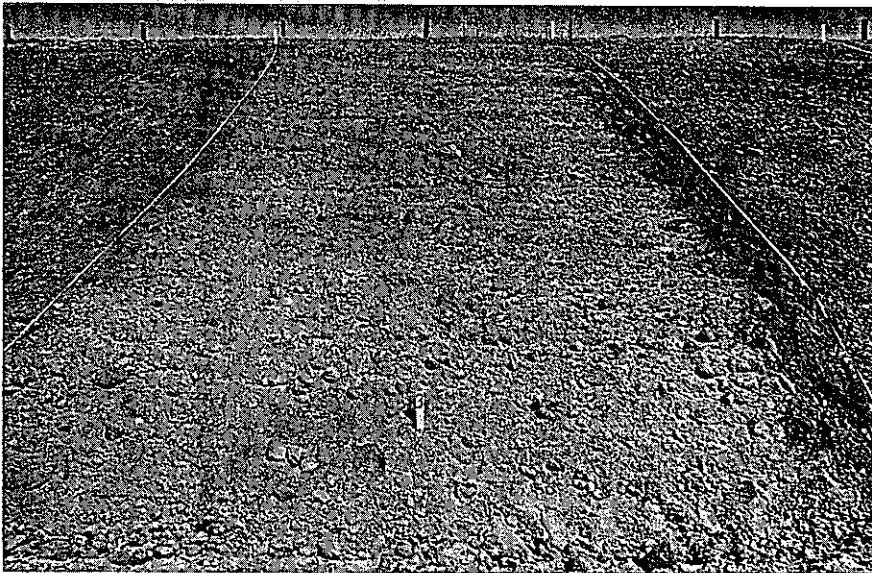
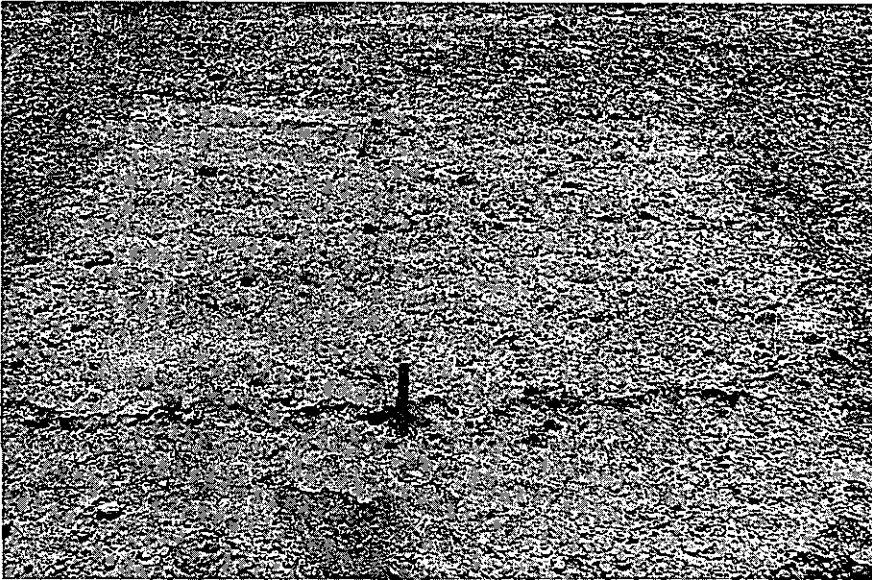
Curasol AE

Plates 10 and 16 show the appearance of the Curasol AE treated test plots.

Four months of weathering caused the Curasol AE crust to soften but it still maintains its integrity and serious erosion is not anticipated. The only vegetation present on these plots occurs in the roller path and consists primarily of native plants but with some barley and rye on the plot that was seeded.

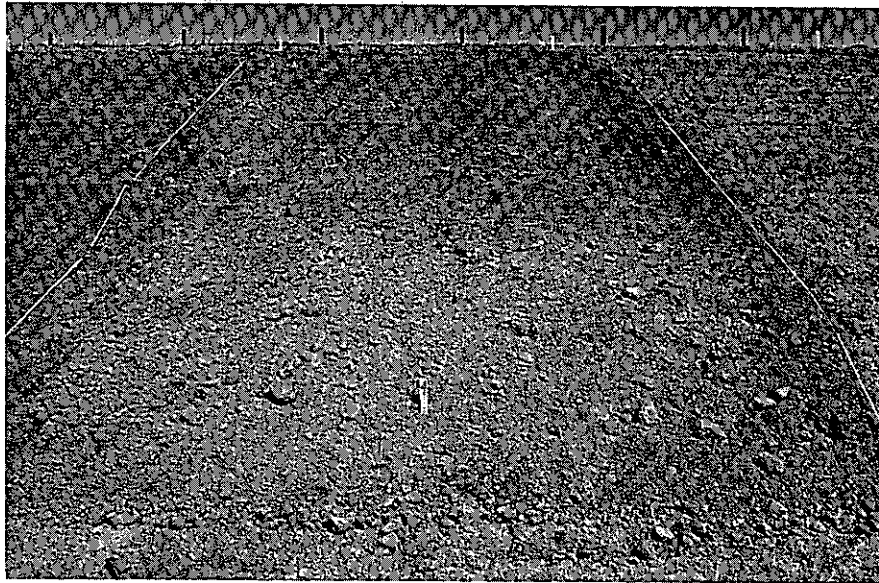
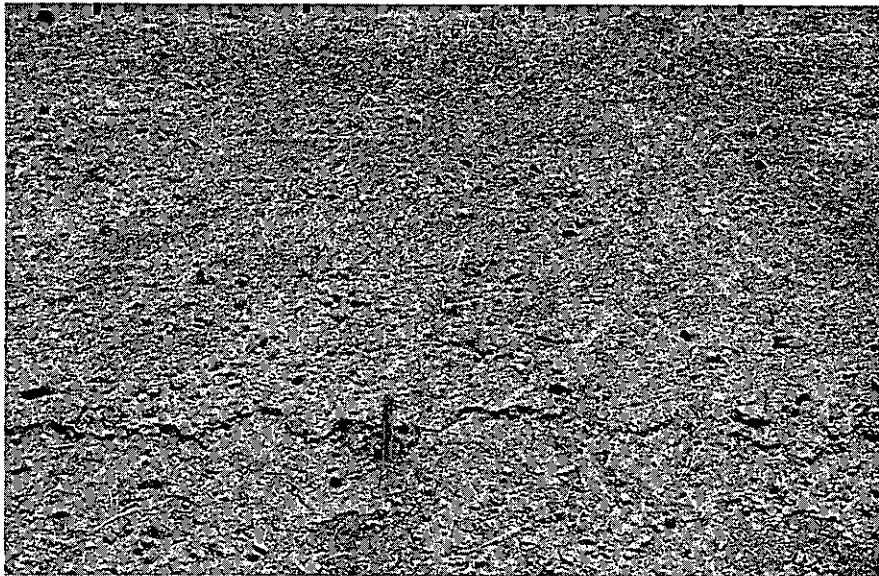
Ecology Control - Seeded

Plates 11 and 20 show the appearance of the slopes that were treated.

Weathering of the Ecology Control test plots has resulted in a softening of the crust. This crust appears to still be continuous and may provide some protection against serious erosion. The unseeded test plot was nearly barren of vegetation (a few native plants in the roller path) and the seeded plot has a few scattered native plants and barley, primarily in the roller path.

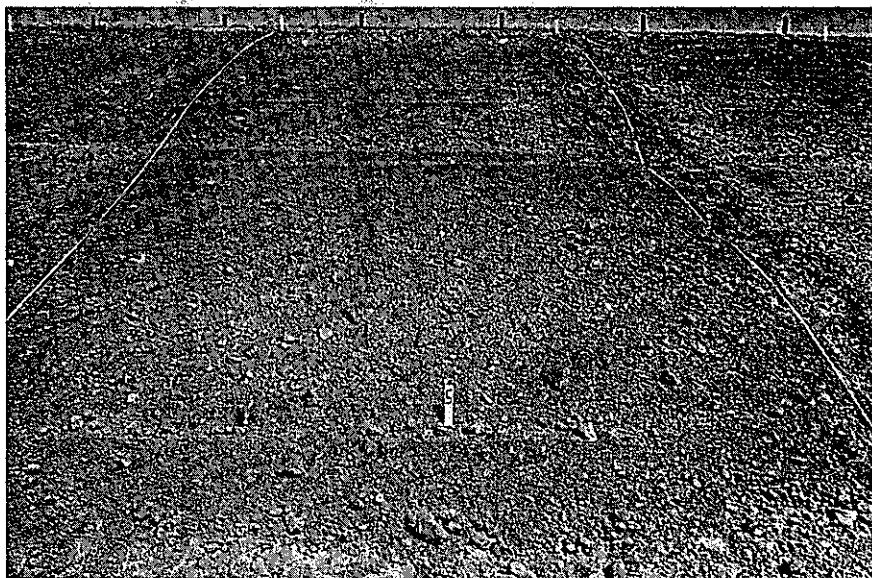
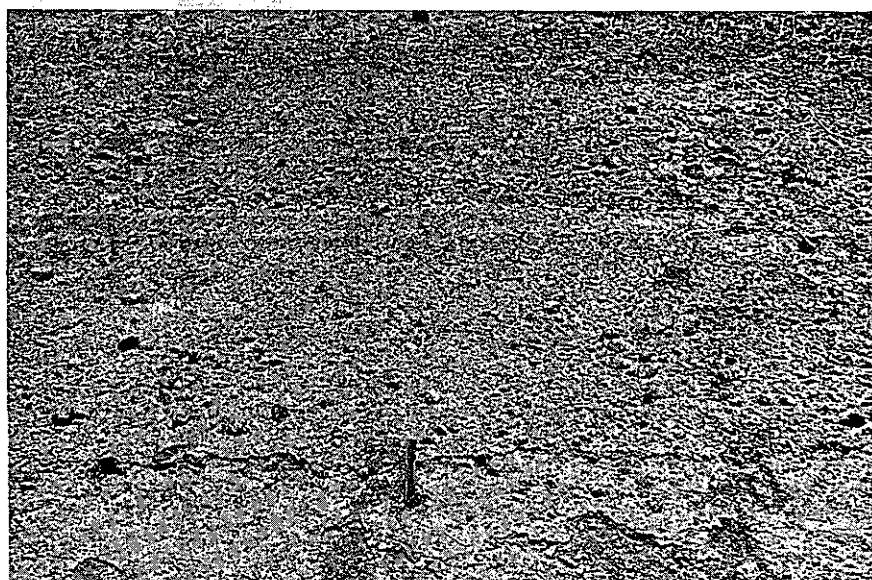
Aquatain

Plates 12 and 21 show the test plots that were treated with Aquatain.

After four months of weathering and spring rainfall the crust was no different than that formed on the untreated test plots, although some of the green coloring remained. Both the seeded and unseeded plots remained virtually bare except for the area over which the roller traversed. Some native plants as well as the seeded grasses sprouted in the roller path. Erosion is anticipated on these test plots. The unseeded test plot was damaged by human footprints.

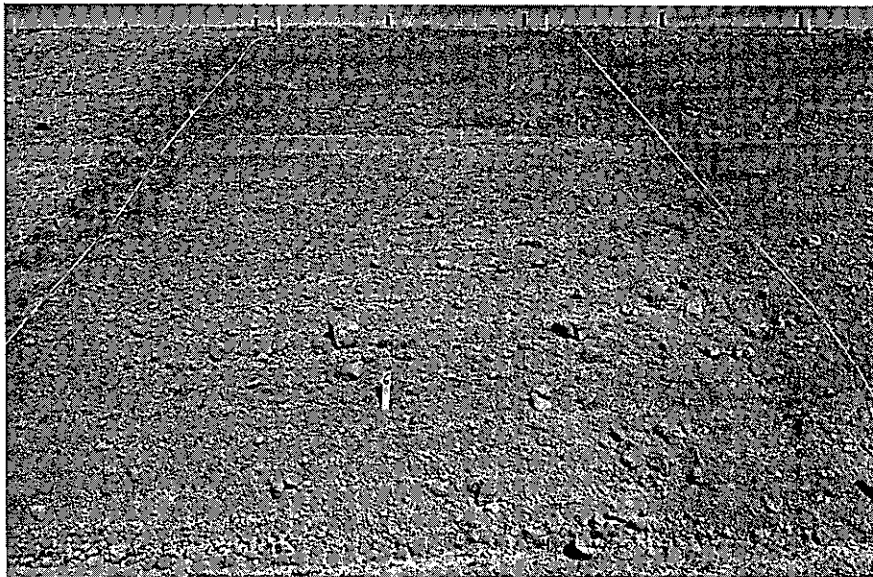
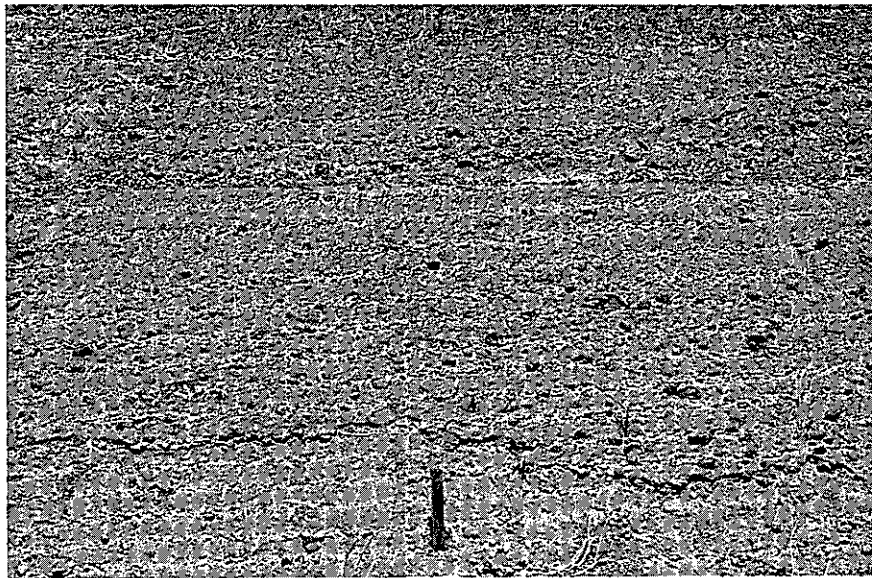
Erode-X - Seeded

Plates 13 and 24 show the test plots treated with Erode-X.

Weathering of the Erode-X treated test plots has resulted in a softening of the crust. This crust is continuous however, and may give some erosion protection. The unseeded test plot is nearly barren and the seeded plot has some native plants and barley which are concentrated in the roller path.

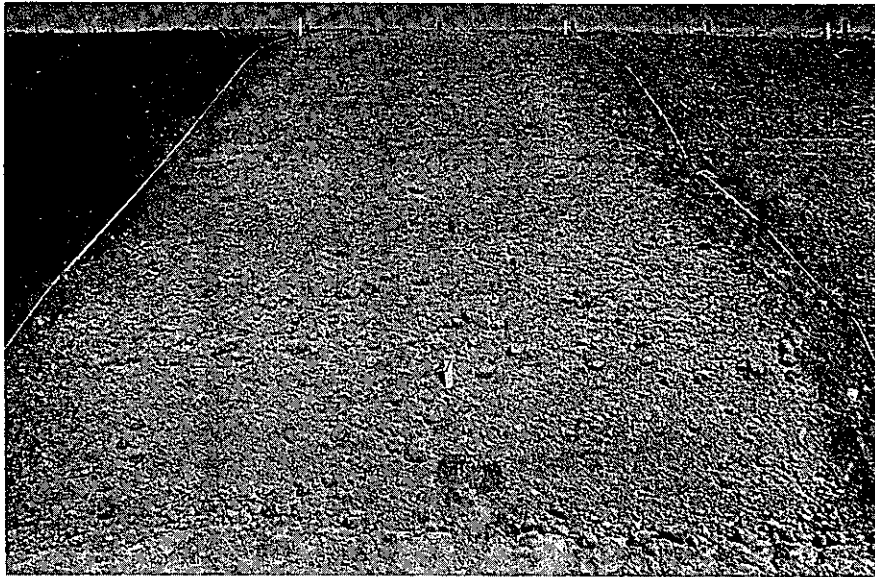
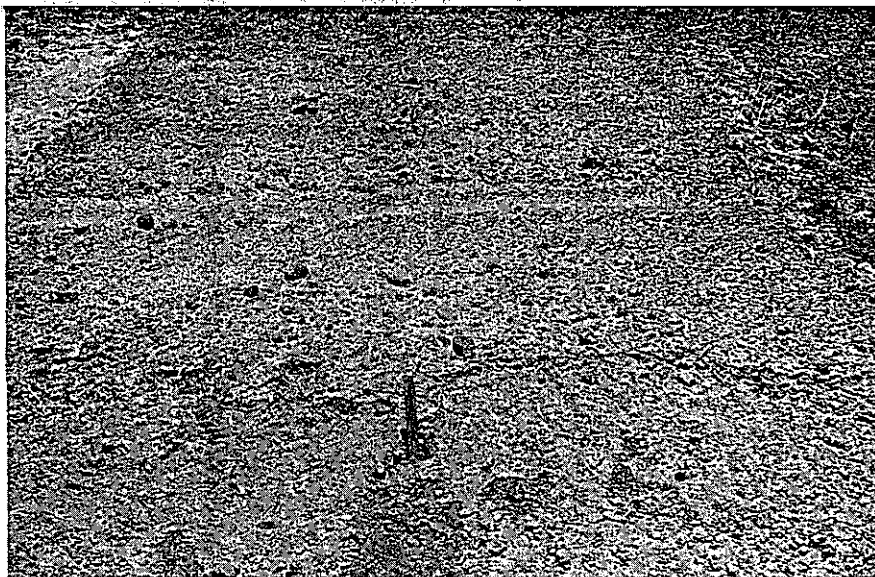
Terra-Krete

Plates 14 and 19 show the appearance of the Terra-Krete treated test plots.

Four months of weathering greatly weakened the crust of this material, however it is still continuous and may provide some erosion protection. The unseeded test plot is barren except for some natives in the roller path. The seeded plot developed some barley and the only rye that reached maturity.

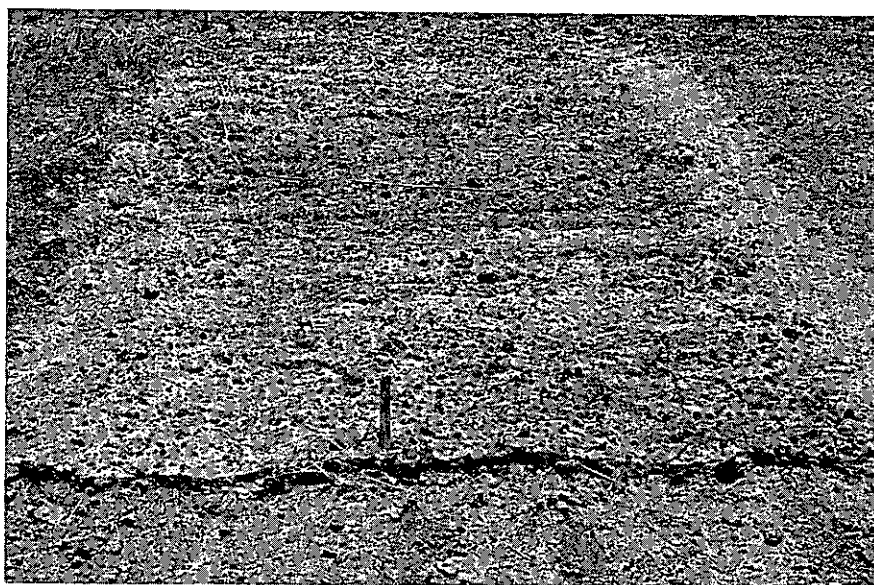
Orzan

Plates 15 and 23 show the test plots treated with Orzan.

Aging of this material results in an extremely hard thick crust which contains numerous shrinkage cracks. These cracks tend to heal themselves upon saturation of the material and then reform upon drying. The material clearly demonstrated its solubility in water, by developing a crust on the slope below the toe as a result of the light runoff that occurred this spring. These test plots are barren except in the roller path where native plants and some barley in the seeded plot did develop. This material will probably provide satisfactory erosion protection for one season in areas of light rainfall or areas of short duration rainfall.

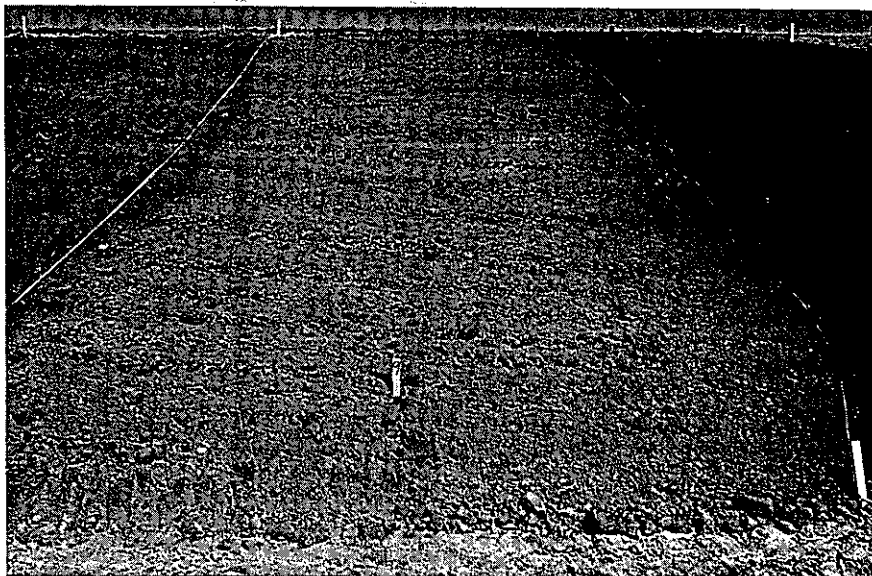
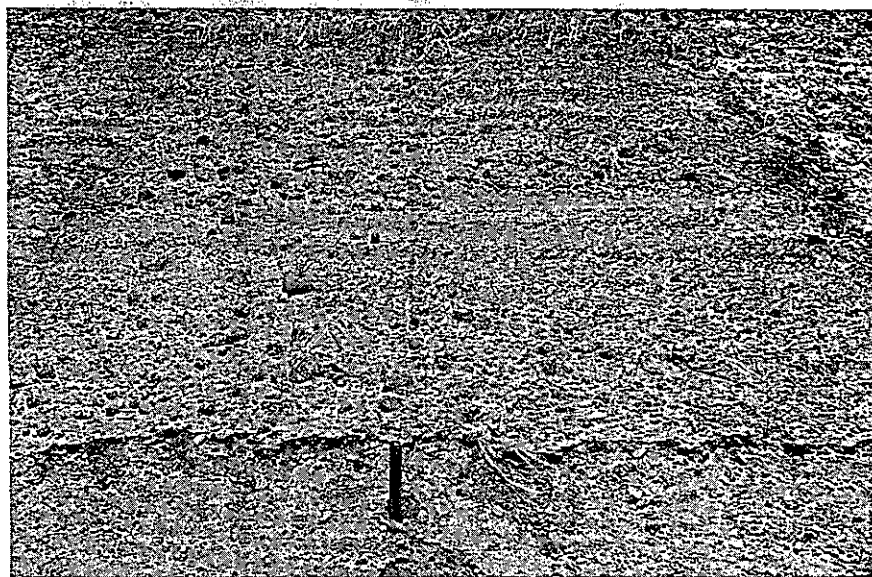
Curasol AE - Seeded

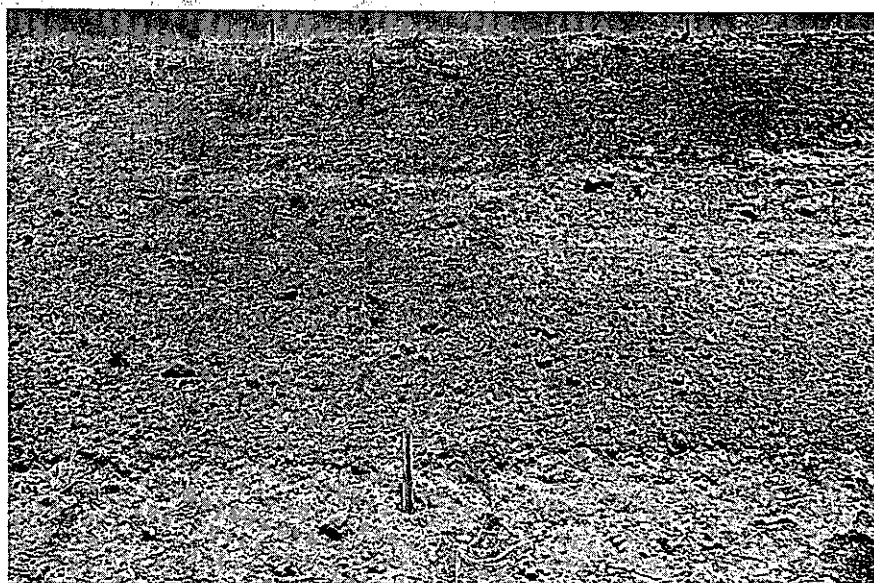
Surfaseal - Bottom half seeded

Surfaseal was applied to only one test plot because of a shortage of material. This test plot is shown in Plate 18. The lower half of the plot was seeded.

Four months of weathering resulted in a thin soft crust on the Surfaseal test plot. The crust on this test plot may provide some protection against erosion. No seeds developed on the test plot but some barley did sprout on the untreated area below the toe. Vegetation, both native plants and barley, sprouted in the roller path. Since no barley was sprayed on the upper portion of the slope, the source of seed is not known.

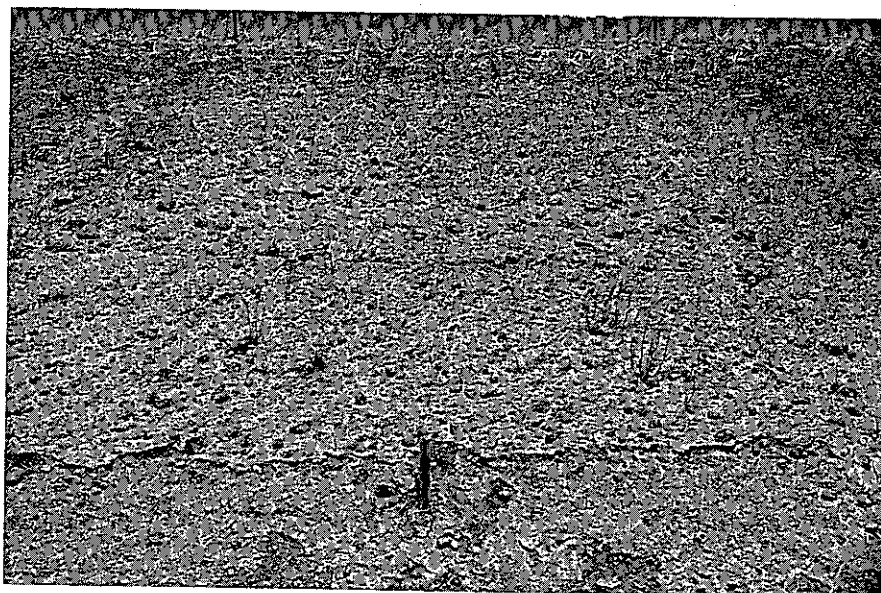
Terra-Krete - Seeded

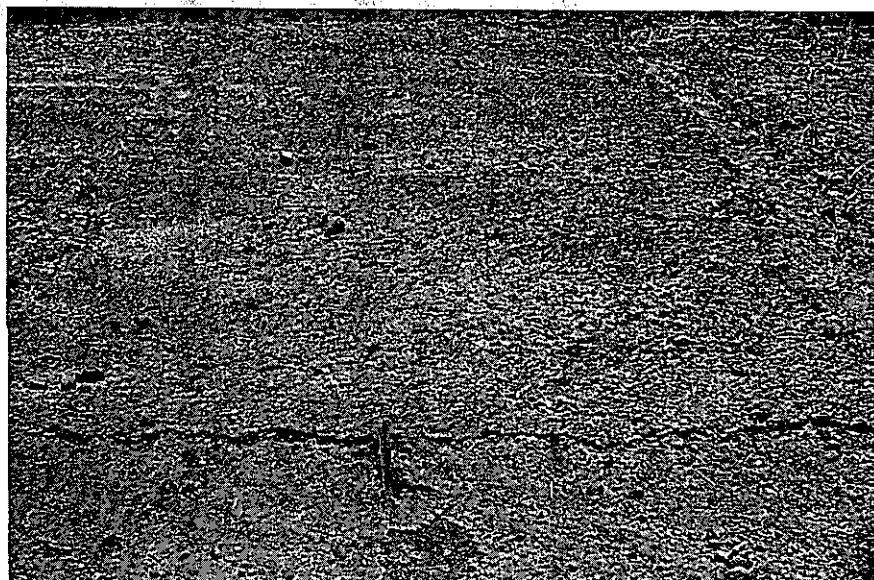
Ecology Control

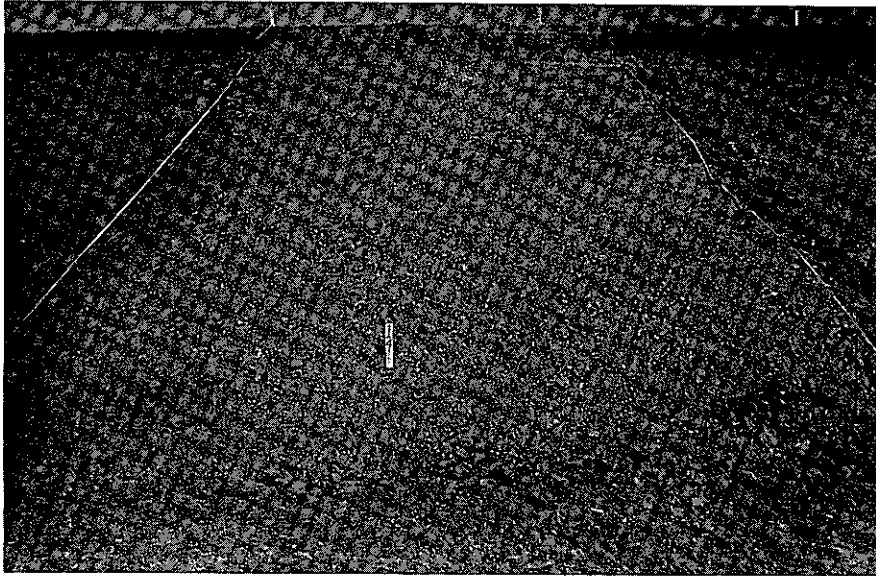
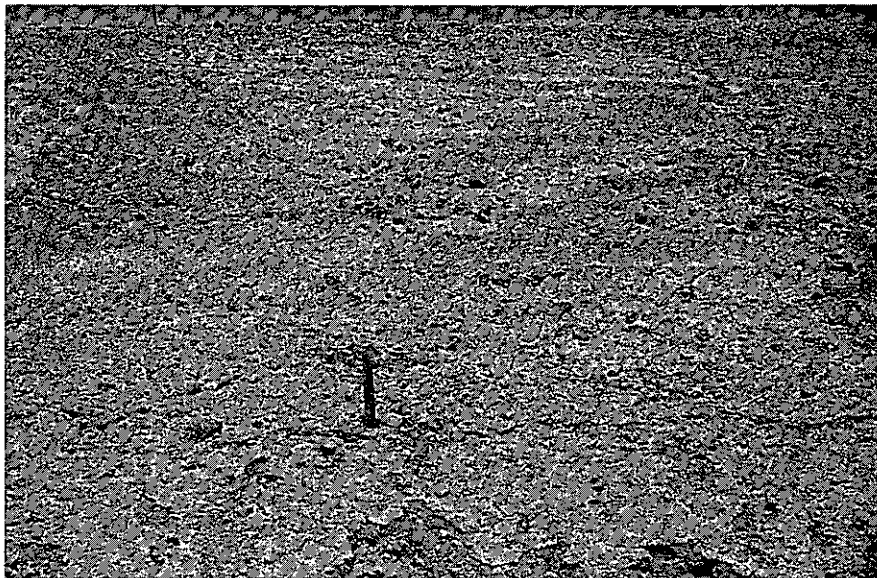
Aquatain - Seeded

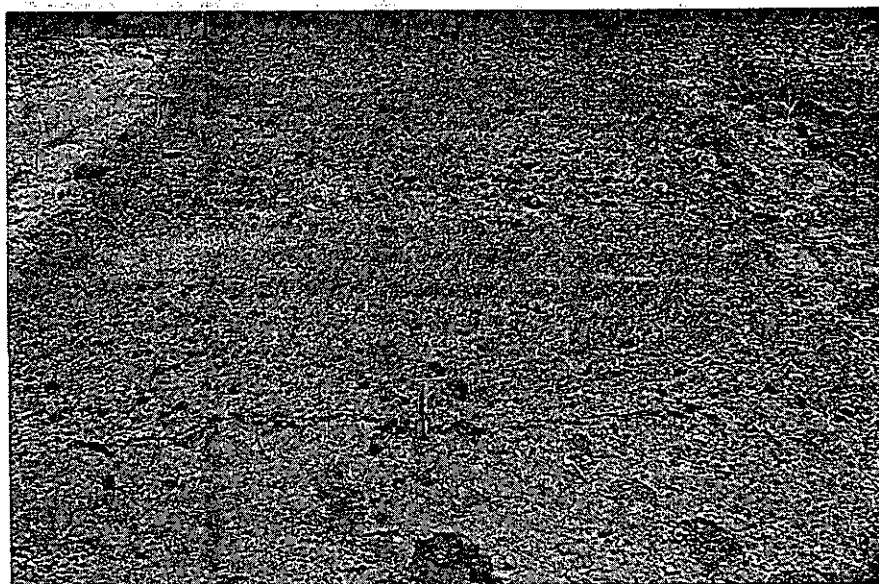
Curasol AH

Plates 22 and 28 show the appearance of the test plots treated with Curasol AH.

The Curasol AH crust appears to have been softened by the four months of weathering, however it is still continuous and may afford protection against serious erosion. Vegetation developed on these two test plots only in the roller path and consisted of native plants and barley.

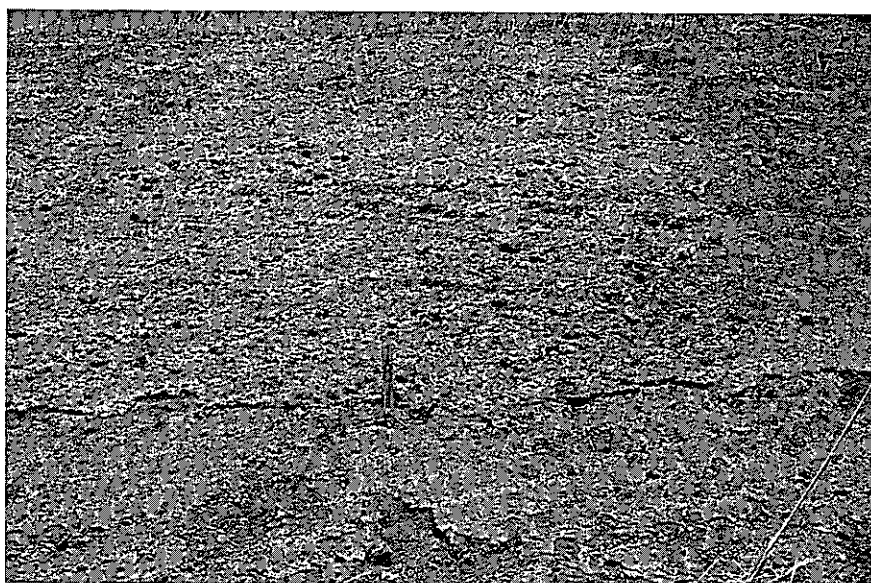
Surftite - Seeded

Plates 25 and 31 show the appearance of the test plots treated with surftite.

Weathering of these test plots has resulted in softening of the crust, which is thin and cracked. Probably this material will leach away rapidly at the start of the next rainy season and the plot will erode. Vegetation grew only in the roller path.

Most of the plants are natives, but good barley developed on the seeded plot.

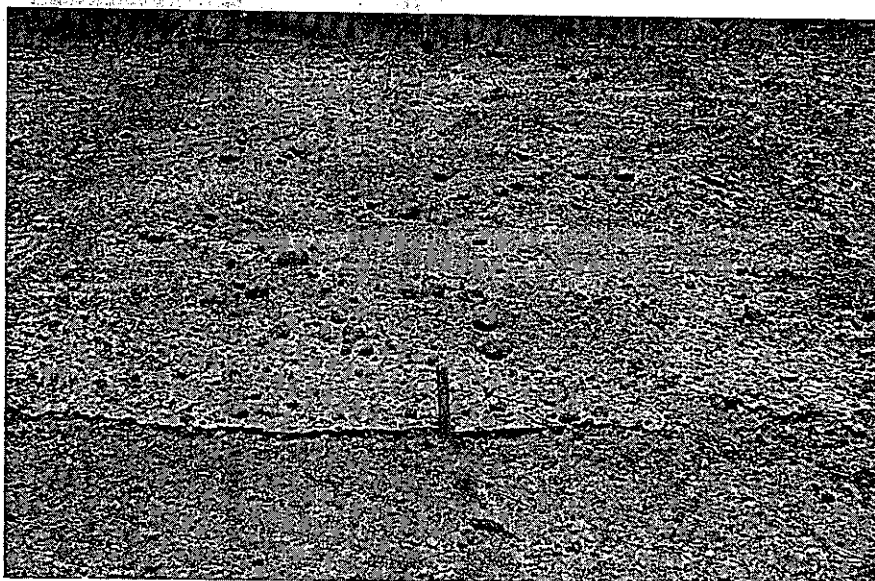
Aerospray 52

Plates 26 and 30 show the test plots that were treated with Aerospray 52.

After four months of exposure, the Aerospray 52 crust was cracked and softened. The unseeded plot was nearly barren except in the track of the straw roller where some native plants had sprouted. The seeded plot had some scattered barley plants but no rye. The crust on this plot has been damaged both by deer and rodents. The combination of the cracked crust, the deer tracks and the rodent damage are expected to permit erosion to take place on this test plot.

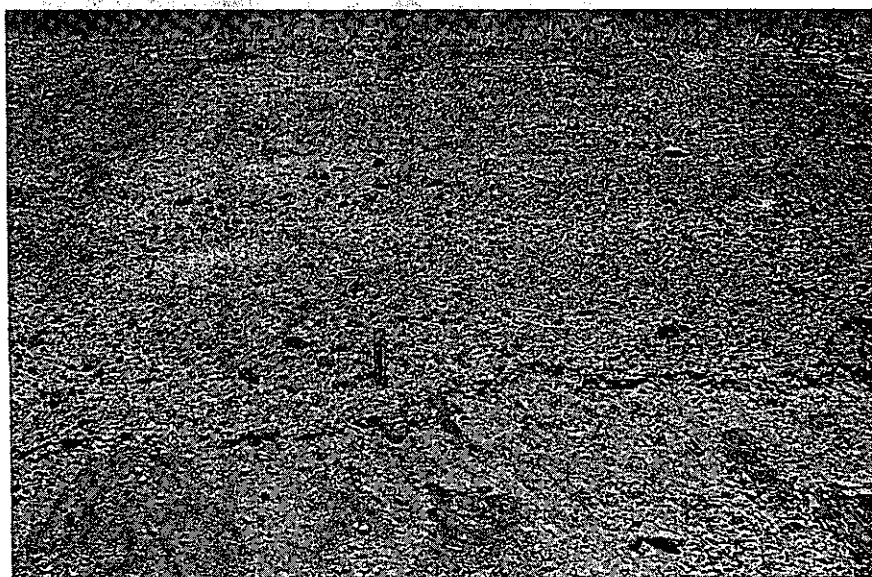
Curasol AH - Seeded

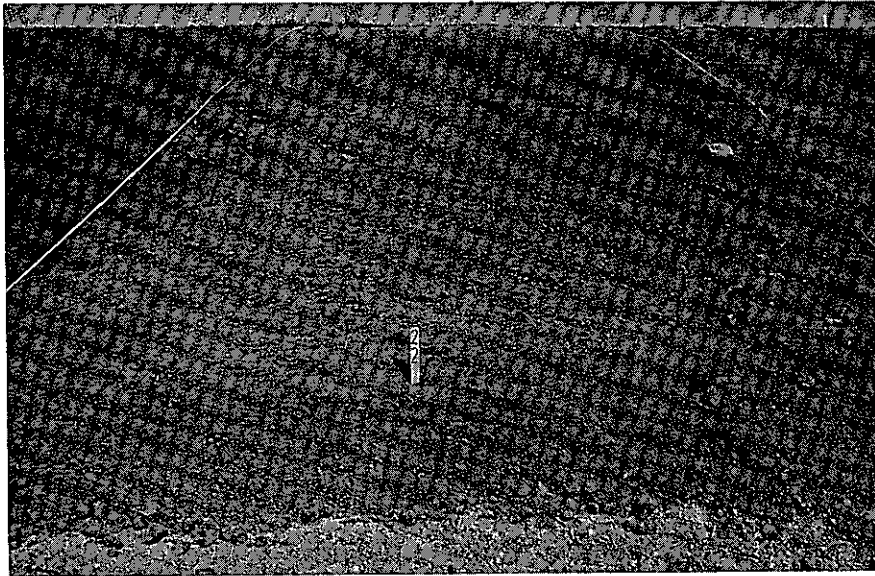
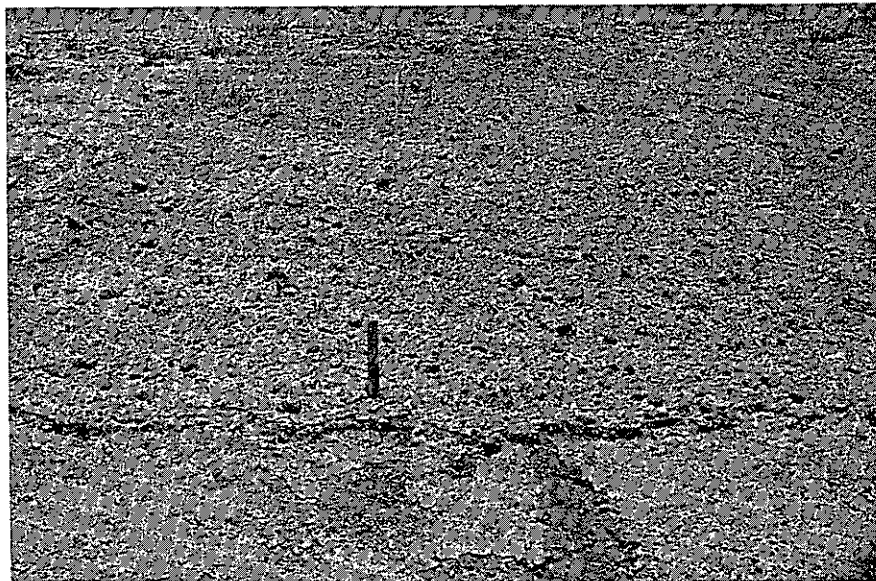
Verdyol Super

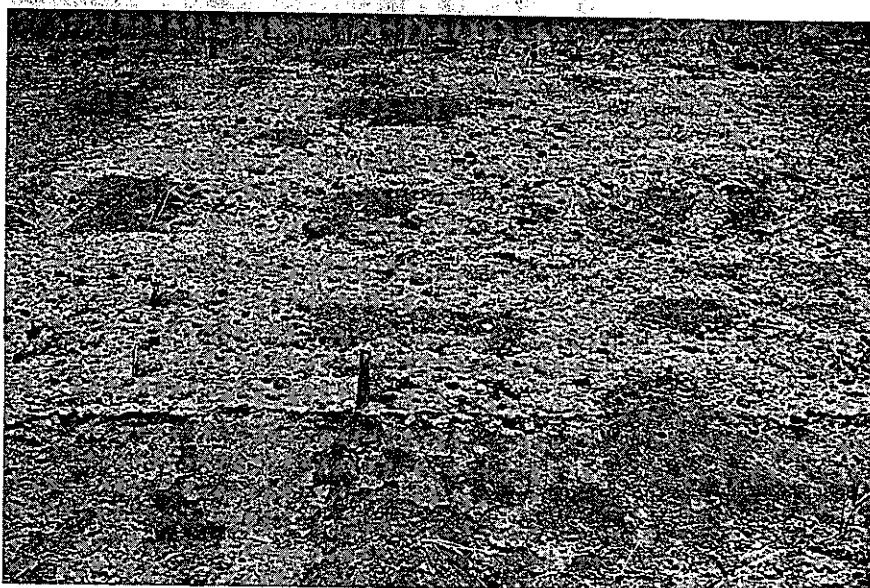
Aerospray 52 - Seeded

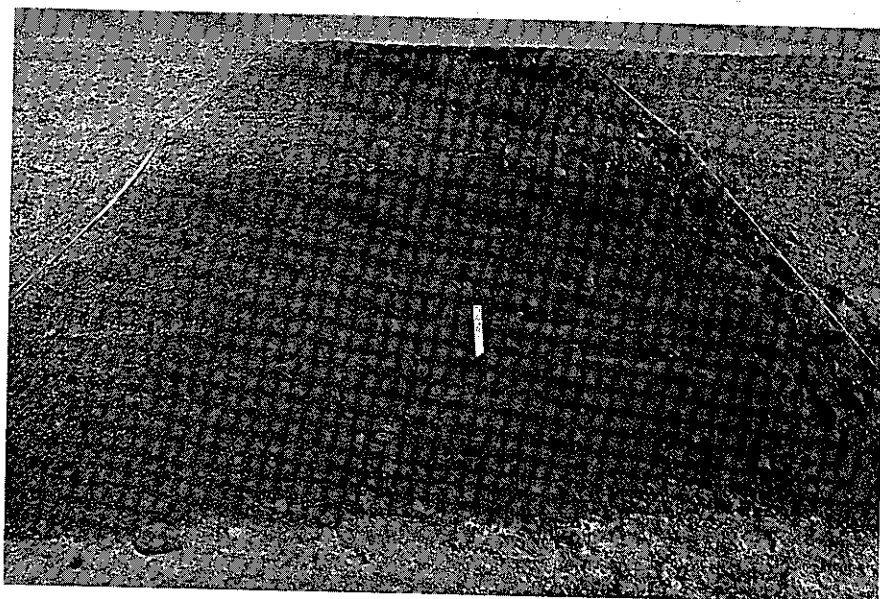
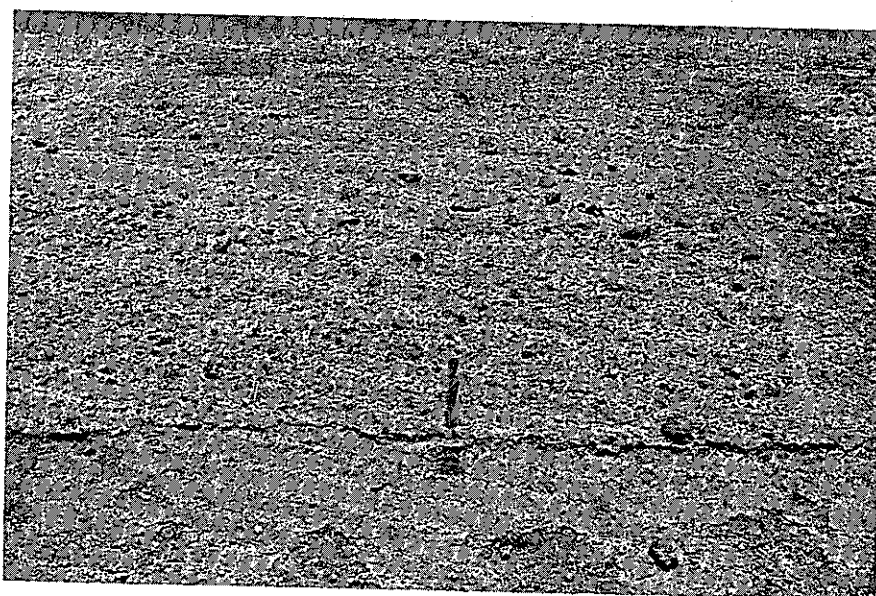
Surftite

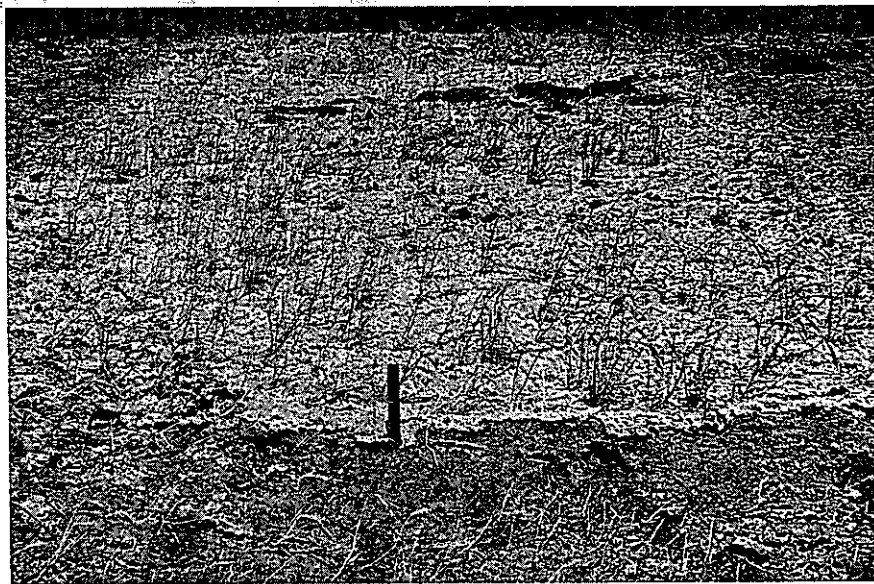
Conwed Fiber - Seeded

The viability of the seeds, at least the barley, is demonstrated by the healthy growth on the Conwed Fiber test plot (see Plate 32). The fertility and plant growing capabilities of the soil are

Plate 32 shows the test plot treated with Conwed Fiber.

After four months, this test plot retained the continuous flexible covering of wood fiber. The plot was severely damaged by the straw roller and rodent activity but will probably not erode because of the continuous nature of the fiber cover and the anchoring effect of the sparse but evenly distributed well developed barley.
